TEST REPORT

Object: Beacon Magnetic Force & Suction Test

Product Name: Magnetic Base Beacon

Report No.: 202371914510

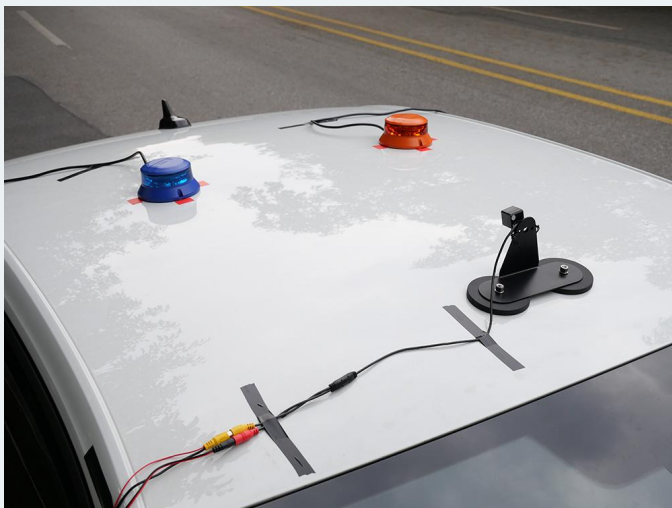
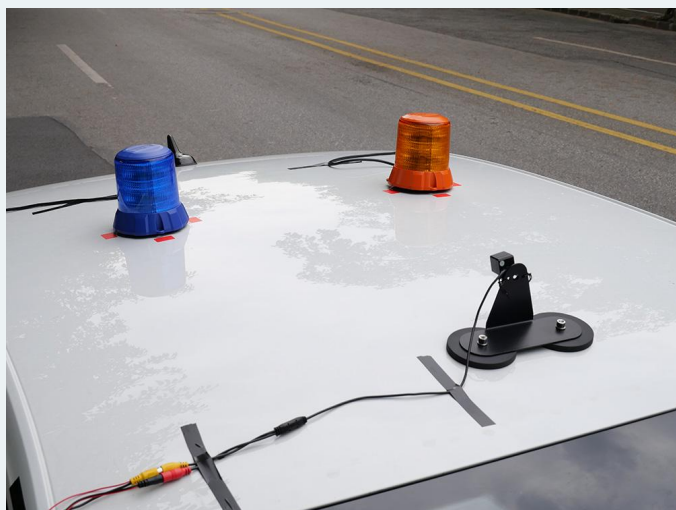
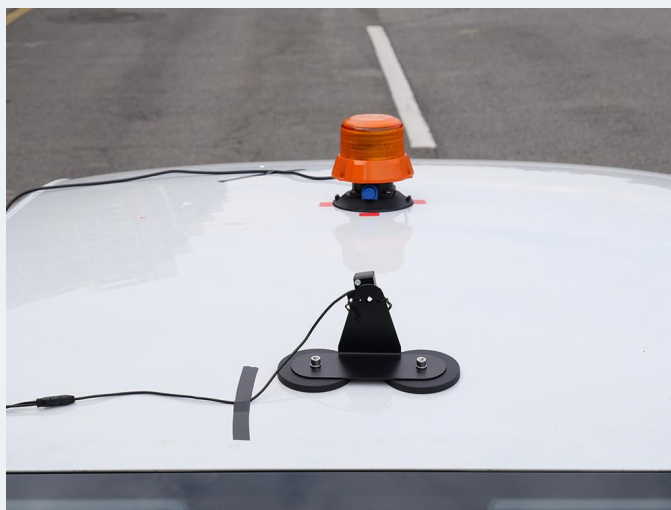
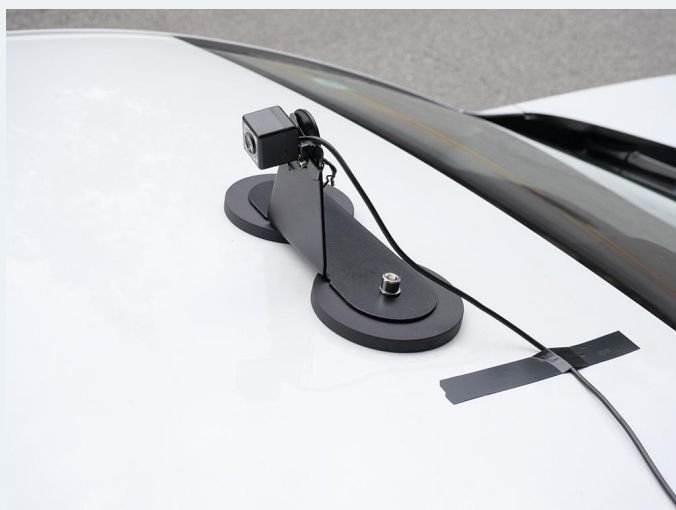
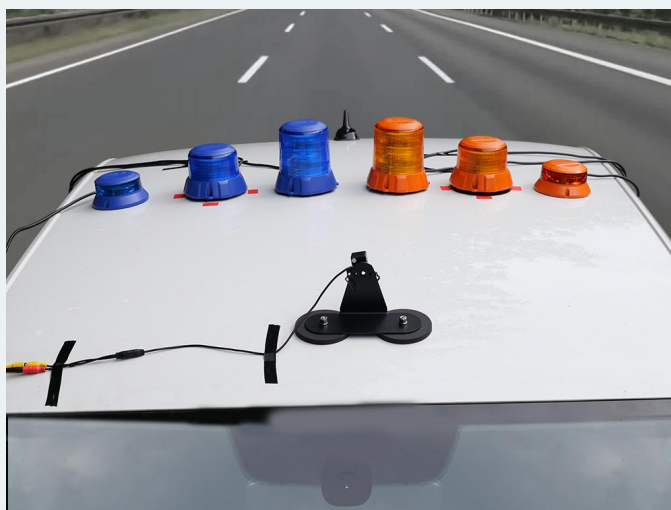
The beacons was mounted at a dry and clean roof of the test vehicle.
Easy installation with magnetic foot. Afterwards was checked if the complete magnetic surface is in contact with the roof.

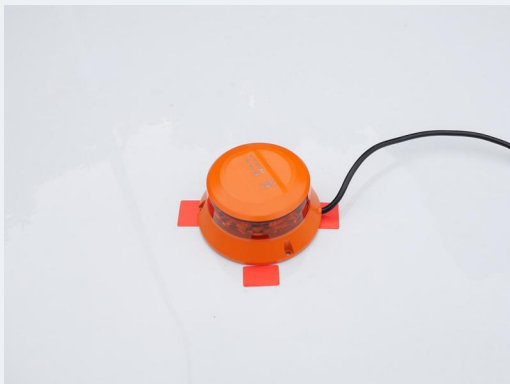
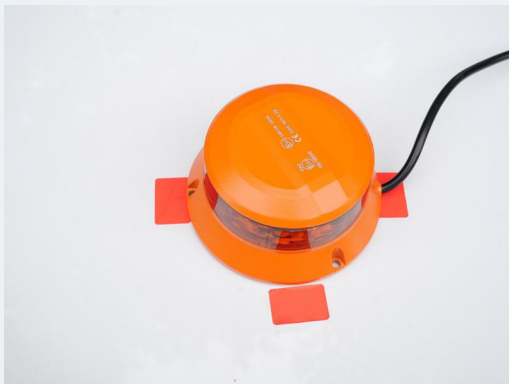
Sample No.	Position before testing	Position after testing
B5-1

No.	High Speed Test	Position after test	Conclusion
B5-1, B5b-1	201km/h	the position remains unchanged	Test pass
B6-1, B6b-1	203km/h	the position remains unchanged	Test pass
B7-1, B7b-1	201km/h	the position remains unchanged	Test pass
B6-3	202km/h	the position remains unchanged	Test pass

No.	Emergency Brake Test	Position after test	Conclusion
B5-1, B5b-1 B6-1, B6b-1 B7-1, B7b-1 B6-3	40km/h	the position remains unchanged	Test pass
	60km/h	the position remains unchanged	Test pass
	80km/h	the position remains unchanged	Test pass
	100km/h	the position remains unchanged	Test pass
